Annual Thaw Slump Expansion on E. Fork Chandalar River, Alaska, 2008-2017

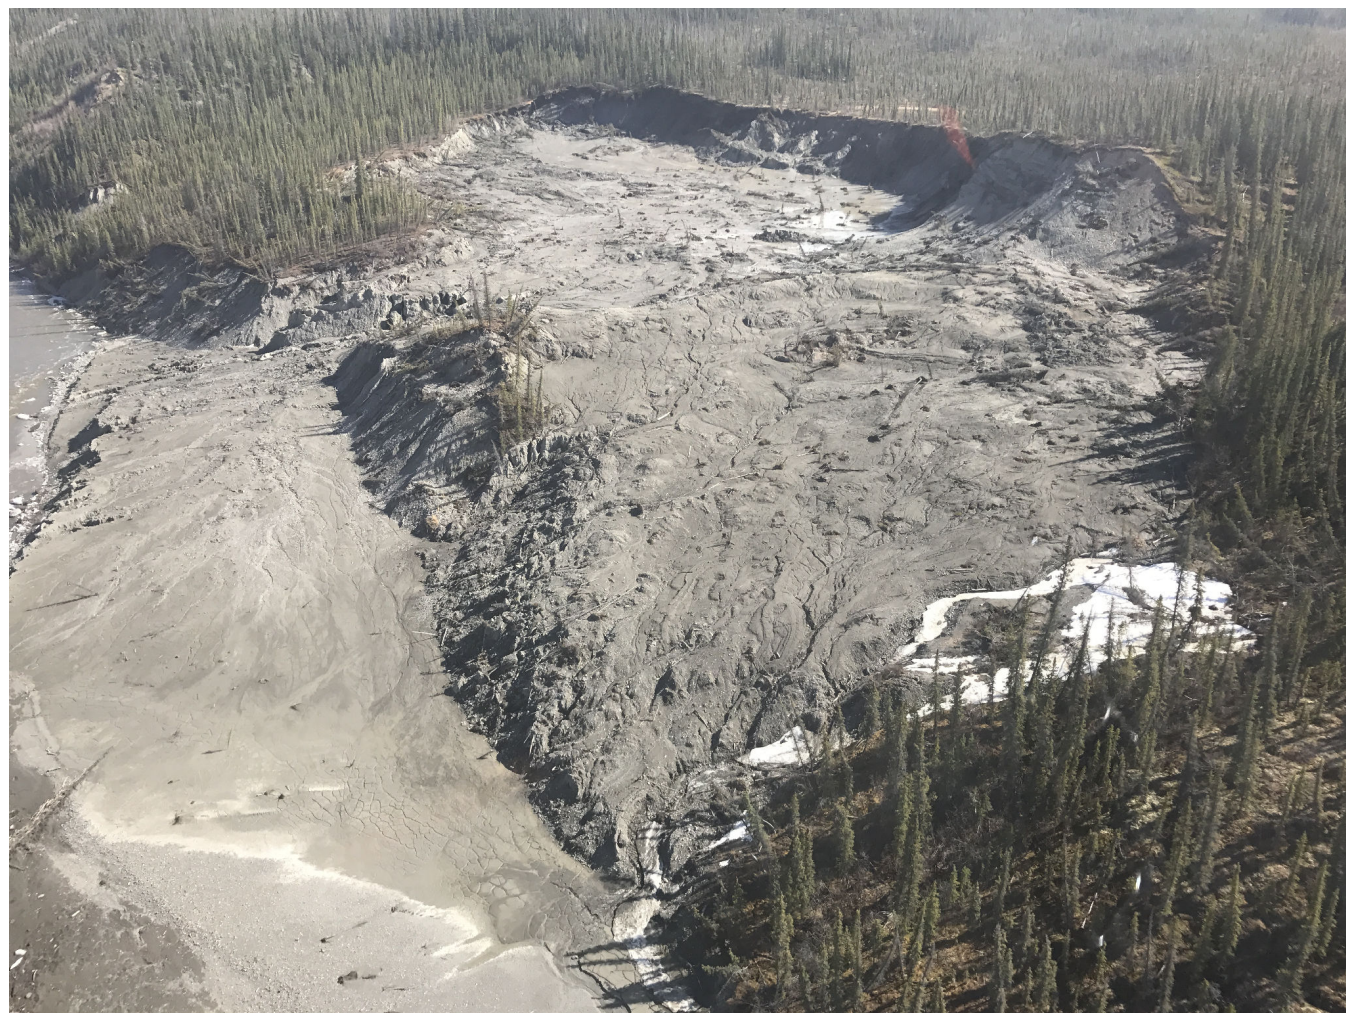
Aerial photo of affected area taken May 16, 2017. The silt on the left of the image appears to have come from the eroded area to the right, building up the eastern bank of the river.

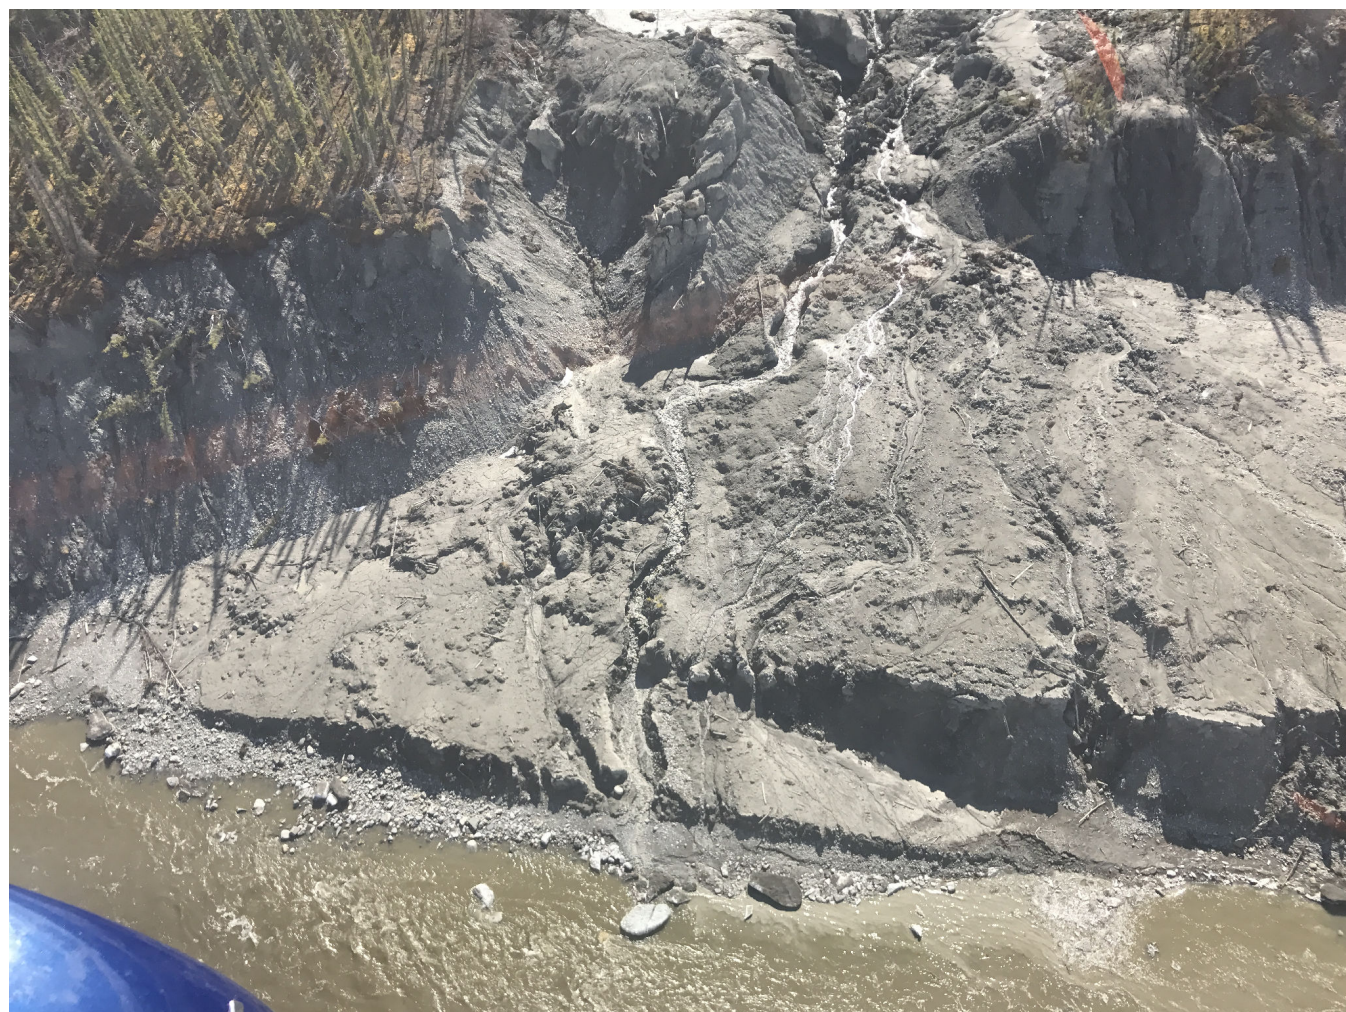
Aerial photo from the same date. Rivulets appear to be forming gullies and accelerating the erosion.
